Odum School of Ecology UNIVERSITY OF GEORGIA

E. coli and Water Quality in the San Luis River and Tributaries in Monteverde, Costa Rica

Amanda Glatter

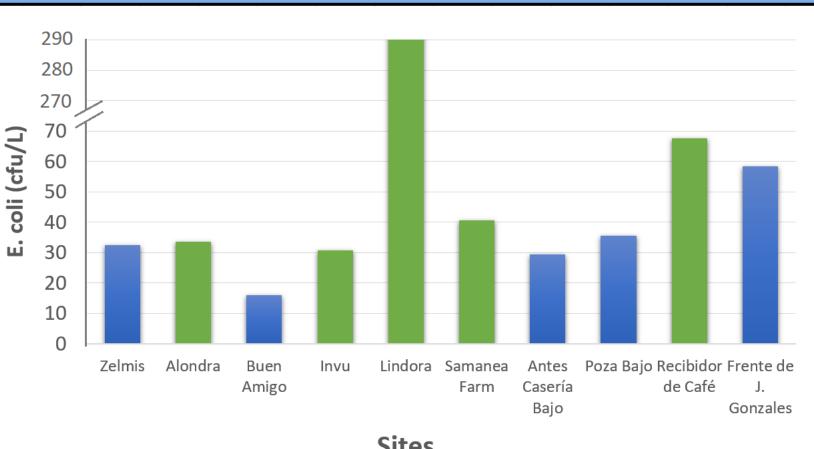
Figure 1. E. coli concentrations (cfu/L) of each 100 mL sample from each site. Blue represents tributaries to the Rio San Luis and green the main stem of Rio San Luis.

• E. *coli* concentrations at each site (Figure 1) remained below the 125 cfu/L limit for water used domestically and recreationally, except for Lindora.

• Lindora's E. *coli* content was 290.9 cfu/L, more than twice as high as the limit

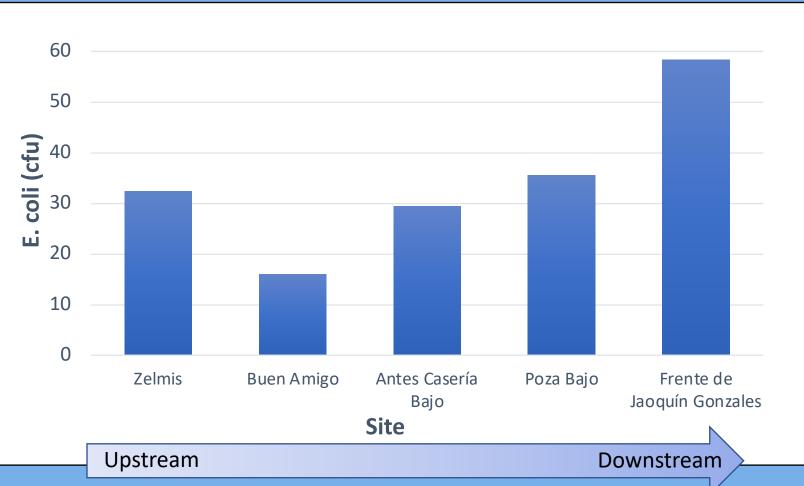
Figure 2. E. *coli* concentrations (cfu/L) for sites along Rio San Luis. **Ammonium and BOD5**

• There is a general positive trend in E. *coli* concentrations (Figure 2) from upstream to downstream in Rio San Luis.

- No sample except Lindora exceeded 125 cfu/L, indicating the water is safe for recreational and domestic use.
- The general positive trend in TSS and E. *coli* down Rio San Luis is consistent with our hypothesis, indicating exposure to runoff from human activity may be a cause of this trend (Figure 2, 4).

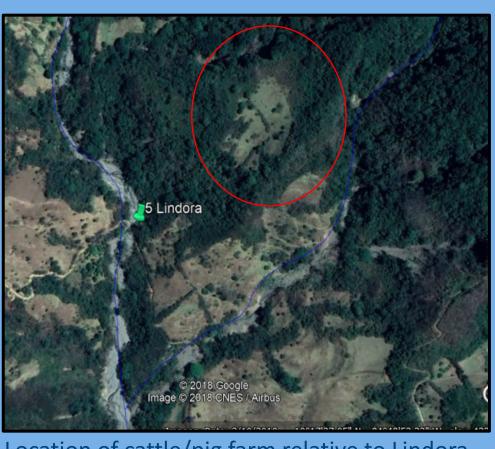
Location of cattle/pig farm relative to Lindora

- Between sites 7 and 8, domestic runoff was spotted seeping from the neighborhood into the stream. High algal biomass was only documented here, indicating potential eutrophication²
- A large cattle and pig farm is located near Lindora, whose runoff may contribute to the high E. *coli amounts*.
